Pearl Harbor Wetlands Inventory

Wil Chee Planning, Inc.
1018 Palm Dr.
Honolulu, Hawai'i 96814

AECOS, Inc.
45-939 Kamehameha Hwy, Suite 104
Kāne'ōhe, Hawai'i 96744-3221

November 30, 2007

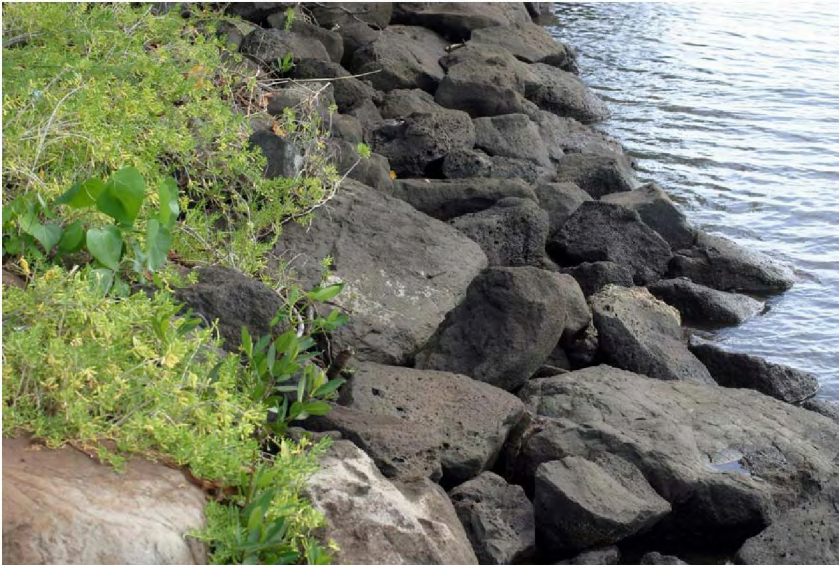
SP5-05 (left):
Shoreline near drainage channel (ID ..7275) is a massive boulder revetment protecting commercial property behind. Note that pickleweed, milo, and red mangrove have colonized the supratidal.

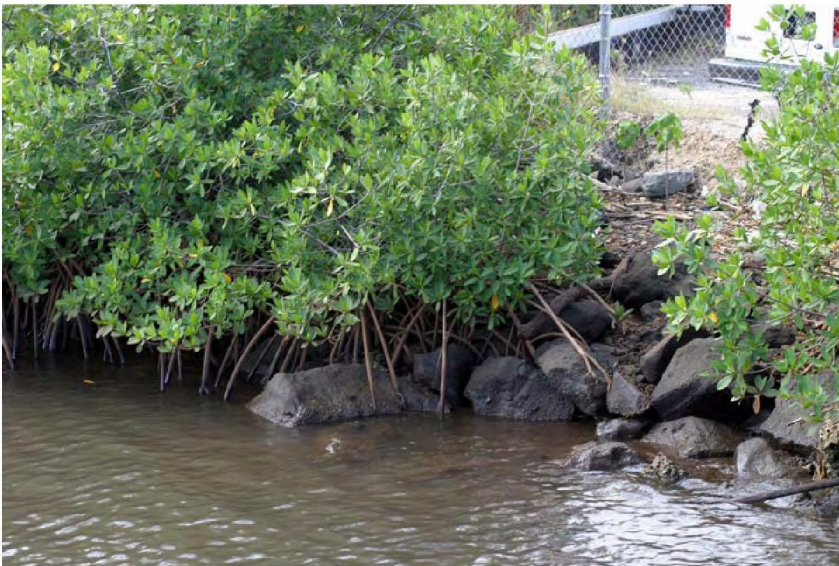
SP5-06 (left):
Mangroves becoming well established on the rock revetment near the photo in SP5-05 (ID ..7153) do not constitute a wetland.

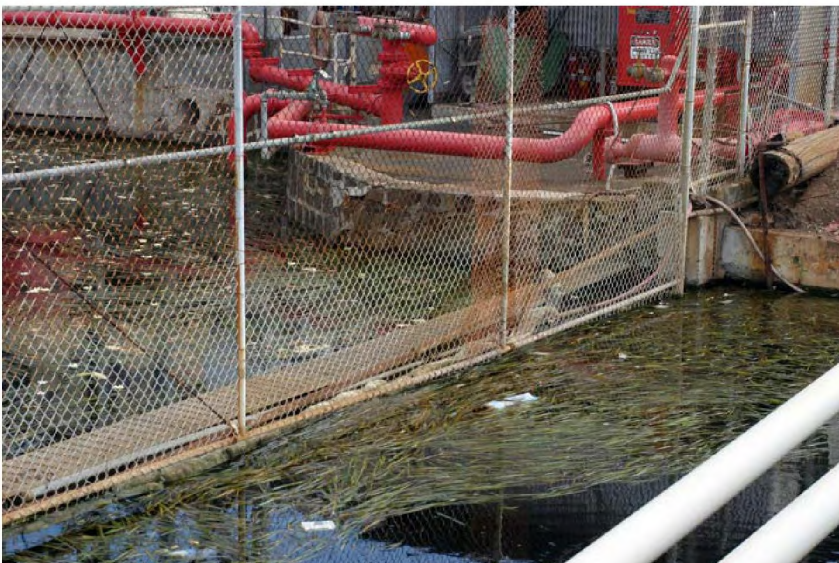
Waiau Pond is an open body of water surrounded on the north, east, and south by walls and bulkheads of the HECO facility. The wetland consists of an open water pond (see photo SP5-07), almost half of which supports tape grass (*Vallisneria spiralis*)—a submerged aquatic plant that is widely used in the aquarium trade and also eaten as a vegetable. During a survey in 2001 (AECOS, 2002), the vegetation of the wetland was found to be mostly cattail (*Typha* sp.) and California grass (*Brachiaria mutica*), but the ACOE (1999) found primarily tape grass. HECO regularly manages the pond by removing water hyacinth (*Eichhornia crassipes*) and other vegetation.

SP5-07 (left):
Connecting channel between ponds at the HECO Waiau Power Station. Note long leaves of tape grass (*Vallisneria spiralis*), a submerged aquatic plant.

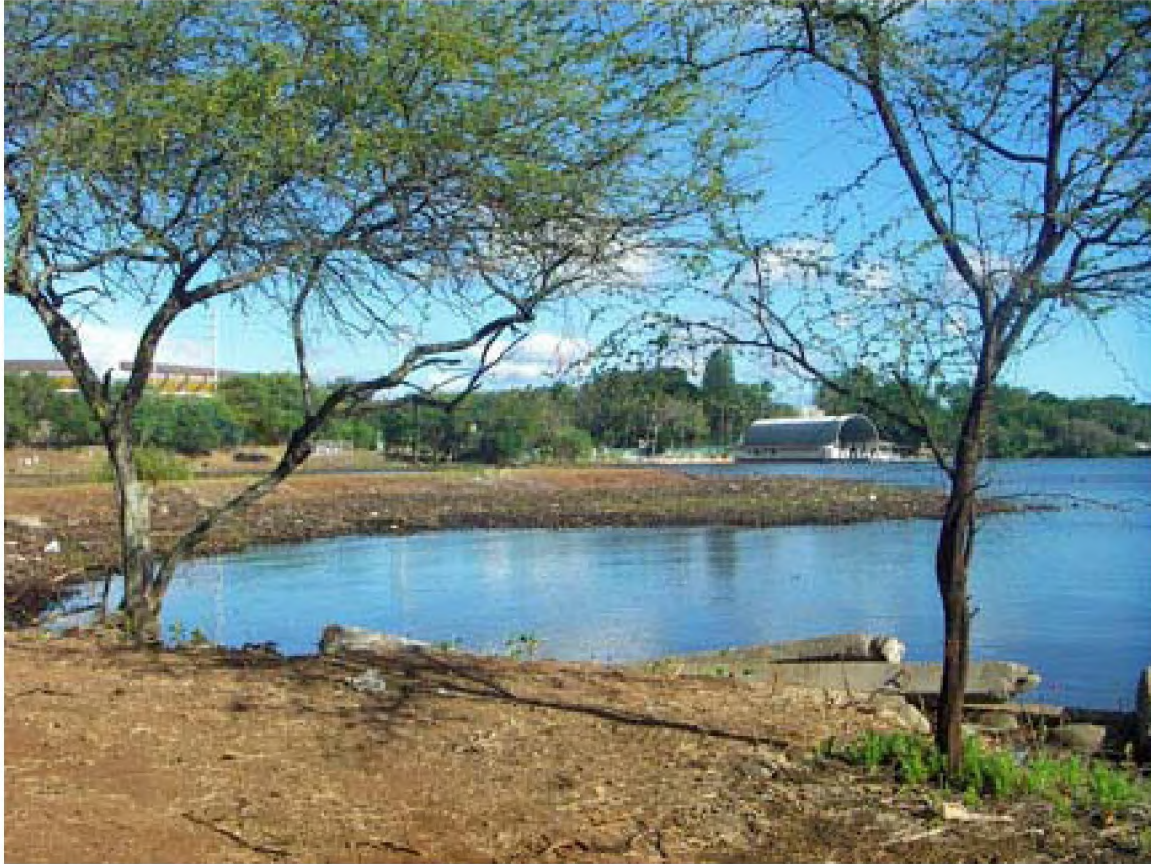
Figure 6-01. View from 'Aiea Bay State Recreation Area across the upper end of 'Aiea Bay showing no mangrove trees present.

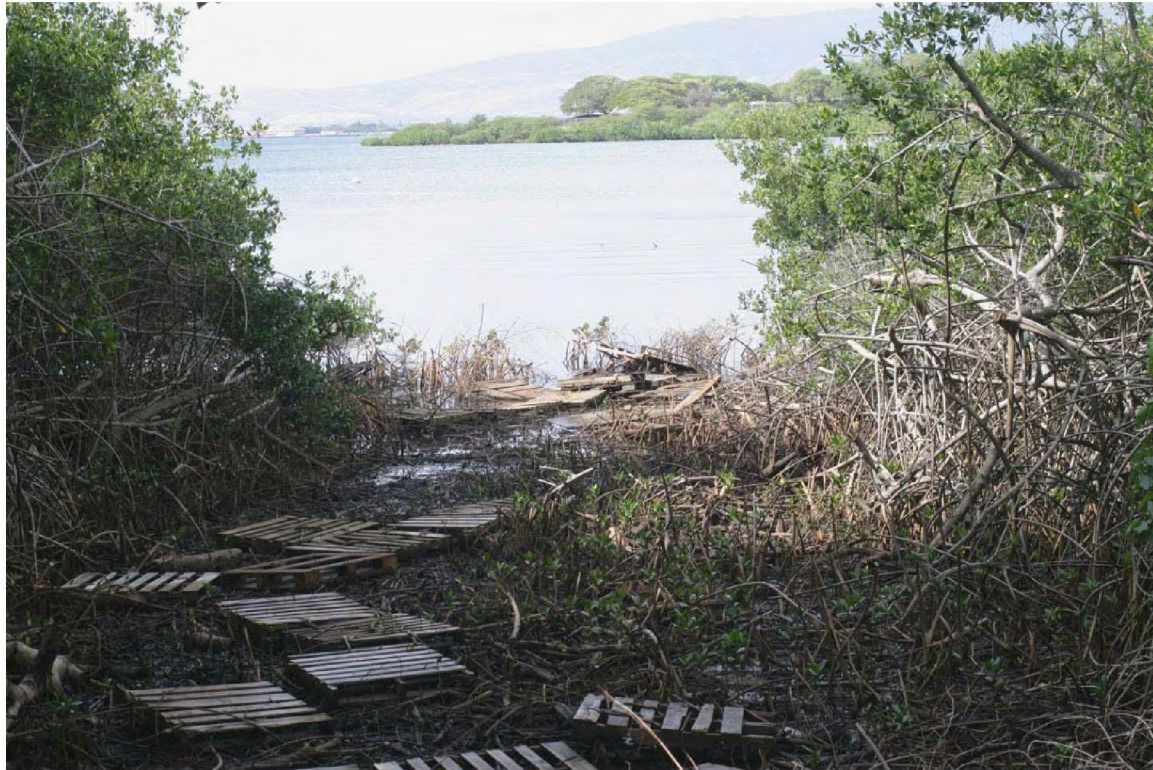
Figure 6-02. Test cut through the mangal (ID ..9034) out to open water of 'Aiea Bay in January 2007. McGrew Point in background. This entire mangal has since been removed.

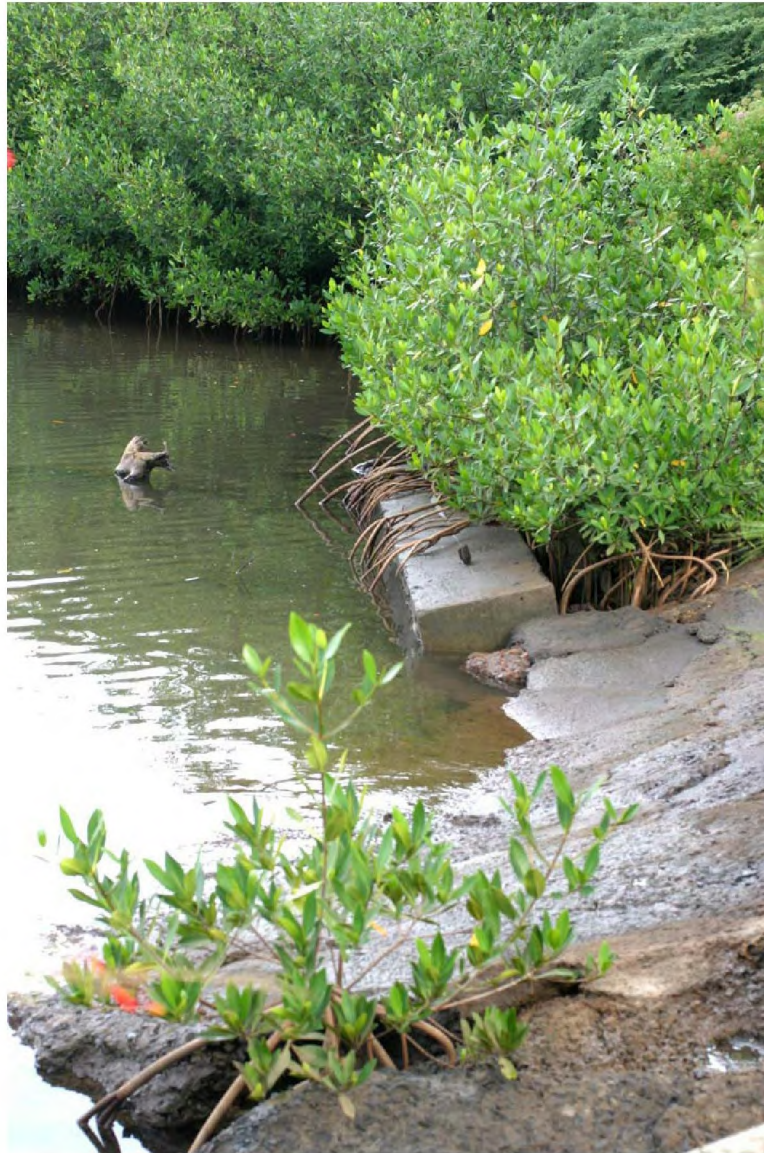
Figure 6-02. Shoreline near the very north end of Navy property on the east side of 'Aiea Bay showing opportunistic establishment of red mangrove on concrete and boulders. Mangal in the background has since been removed.

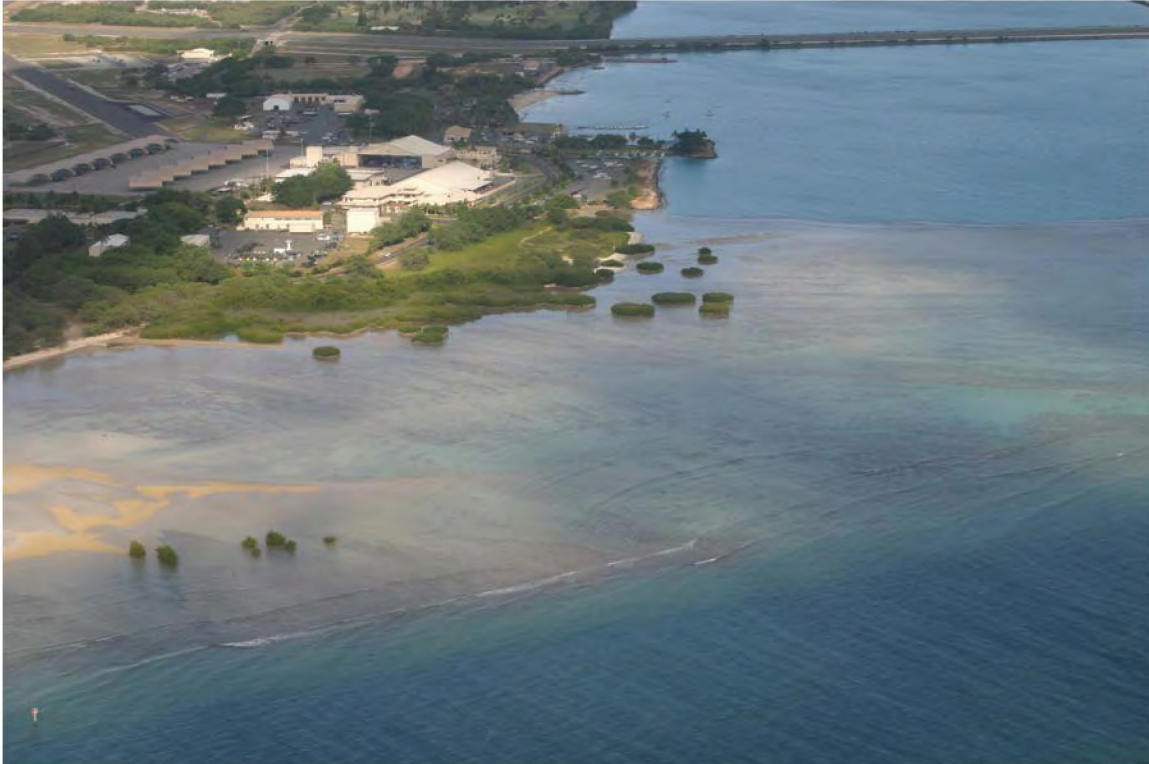
Figure 6-03. Aerial view of mangrove growth extending onto the reef flat off Fort Kamehameha at the mouth of Pearl Harbor (4/11/07).

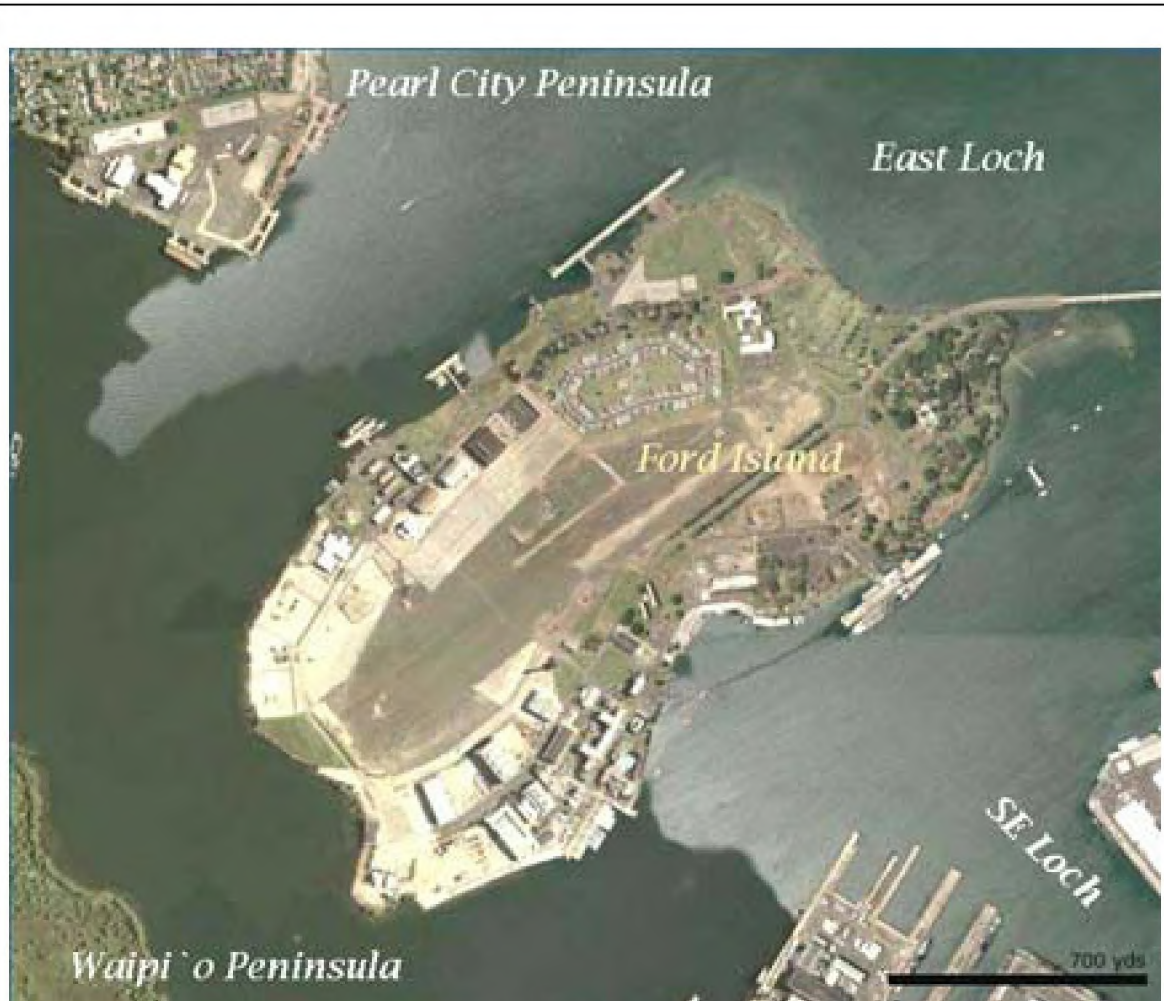
shoreline reflects a long history of ramp, pier, and dock construction, bulkheads and revetments, and land fill. The interior is completely developed as an airfield, other Navy facilities of various sorts, including new Navy housing projects (Fig. 6-04).

Figure 6-04. Satellite image of Ford Island (Microsoft Corp., 2006) showing relationship to adjacent areas of Pearl Harbor and U.S. Navy facilities that completely cover the island.
